## Damage Assessment of Building Materials and Conservation Recommendations for Karacabey Ulu Mosque in Bursa

**Keywords:** Damage, Material Problems, ICOMOS-ISCS, Restoration, Conservation.

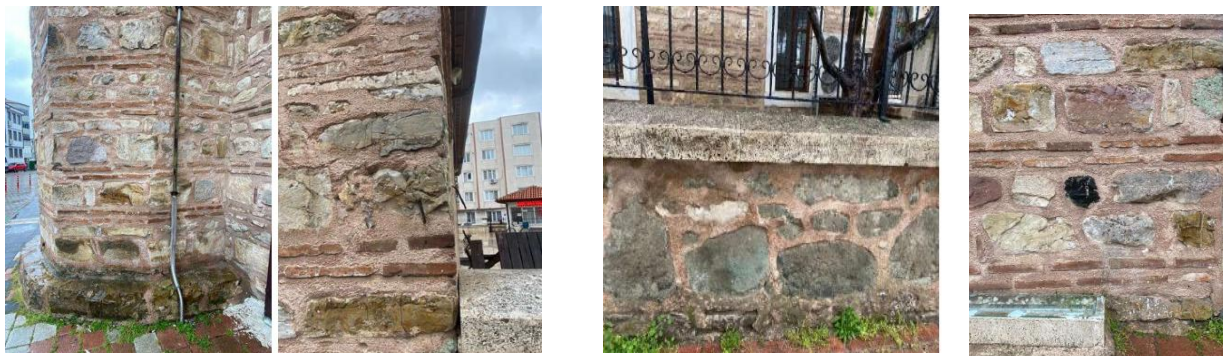
The most common deterioration observed on the walls includes intense discolouration visible across nearly all surfaces, along with dirt accumulation and surface soiling (soiling and deposit). Biological colonization is also widespread, particularly in lower and humid areas, in the form of moss and algae growth (Figure 3).

**Figure 3.** Material deterioration observed on walls (Özçelik, Z. S., 2026)

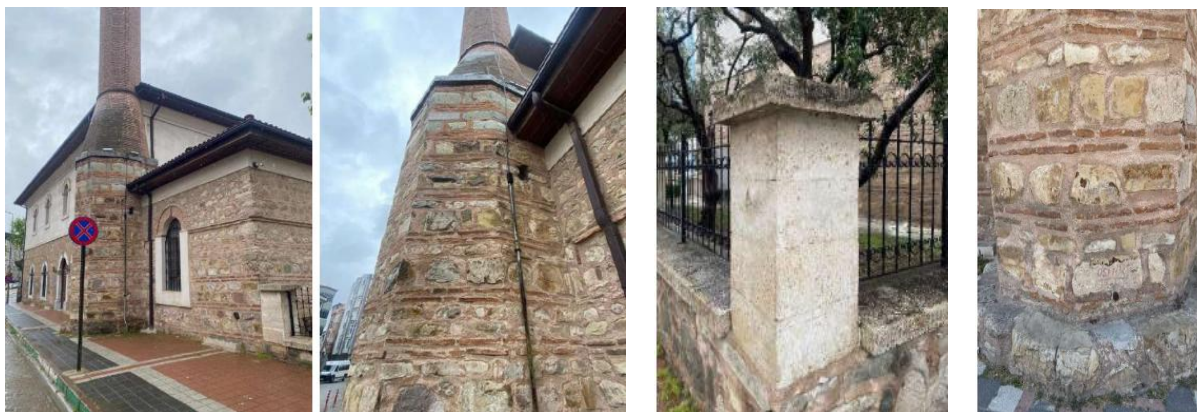
Significant erosion and material loss are evident on stone surfaces, while cracks are commonly observed in both stone and brick elements. Material detachment is present in the form of blistering, peeling, and scaling. In certain areas, structural disintegration of stones is observed, along with localized loss of small stone parts (missing parts). Some stones exhibit patina formation, and slight efflorescence is visible near the eaves. Additionally, crust formation is observed in the white plastered areas. No deterioration was identified in the wooden columns visible in the interior, as they have undergone restoration (Figure 4).

**Figure 4.** Material deterioration observed on walls (Özçelik, Z. S., 2026)

For the cracks exposed after surface cleaning on the walls, epoxy resin injection is recommended. For cracks too wide for injection, a portion of the brick or stone material along the crack should be carefully removed and repaired using compatible materials and stitching techniques. It is essential to investigate whether the observed cracks are caused by earthquakes or other structural factors. In future studies on the stone structure, it would be more appropriate to first examine seismic effects and then develop restoration proposals for the cracks accordingly. Cracking problems in historic stone structures may arise from multiple causes, including natural weather conditions, foundation movements, soil problems, deficiencies in the load-bearing system, structural inadequacies, and earthquakes. In addition, cracks in stone and the processes leading to their formation are influenced not only by climatic and anthropogenic external factors but also by intrinsic material properties such as texture, mineralogy, porosity, and pore size distribution. In this context, future studies should adopt an integrated approach that combines experimental analysis of existing materials with investigations of seismic effects in order to inform the design of appropriate restoration materials. Failure to accurately identify the causes of cracking and the implementation of inappropriate interventions may lead to irreversible consequences.

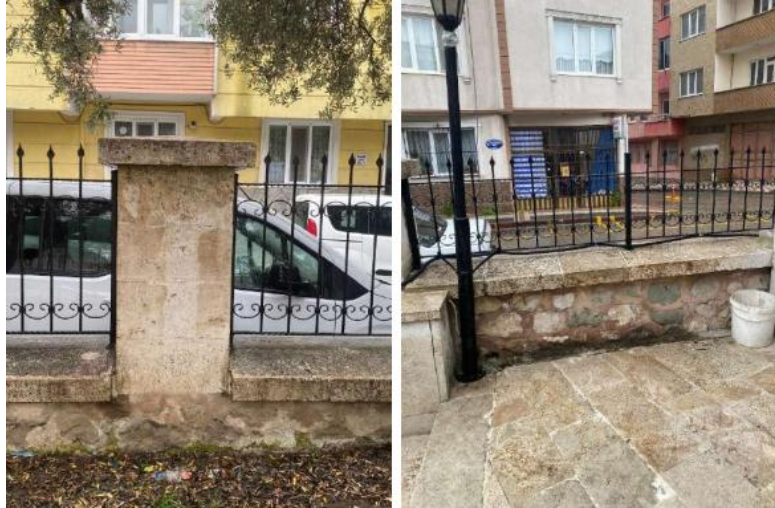
The most prominent issues observed on the floors include intensive erosion caused by human use and environmental factors, as well as mechanical damage. Particularly along circulation paths and entrance areas, significant wear and polishing of stone surfaces are evident. In some areas, cracks have developed, along with moisture-related discolouration and surface soiling. Biological colonization in the form of moss and algae layers has also been identified in certain areas, and small fragments have detached from stone edges (detachment and missing part) (Figure 5).

**Figure 5.** Material deterioration observed on floors (Özçelik, Z. S., 2026)

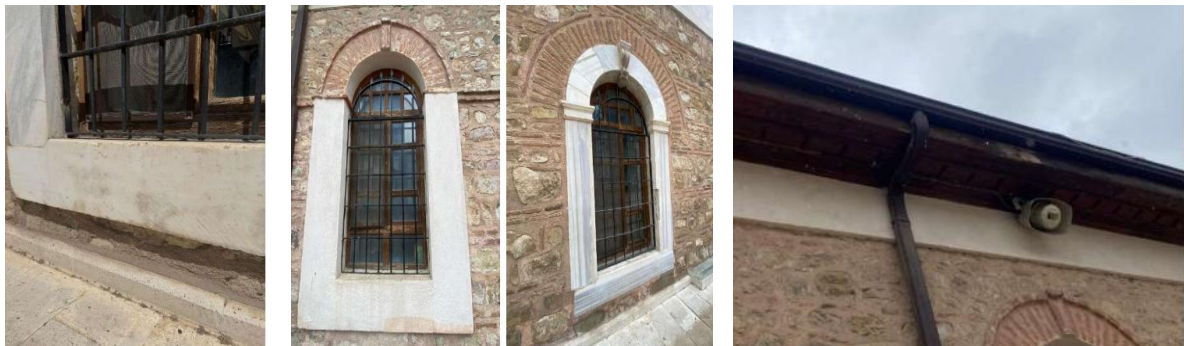
In auxiliary elements such as decorative features, mouldings, arches, chimneys, window pediments, and eaves, several types of deterioration have been identified. Chimneys, eaves, and window mouldings exhibit intense discolouration, along with significant dirt accumulation (soiling and deposit), particularly in chimney and eaves areas. Erosion leading to surface loss is observed on chimney stones. In lower and humid areas, widespread biological colonization in the form of moss and algae is present. Cracks have developed on mouldings and around window elements, while material detachment in the form of peeling is observed on window mouldings. Additionally, crust formation is evident in the areas beneath the eaves (Figure 5).

**Figure 6.** Material deterioration observed on auxiliary elements (Özçelik, Z. S., 2026)
