The Deterioration Problems Observed in the Natural Building Blocks of Saint George Church in Diyarbakır Province

Murat Dal

Abstract

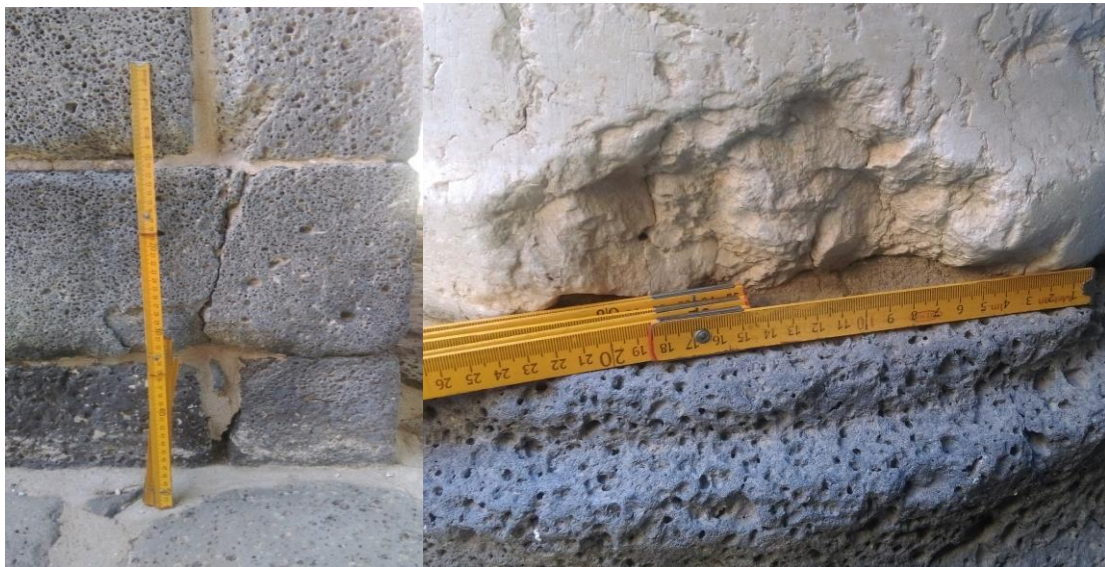
Mechanical degradation was observed as a result of the building's losing its qualities due to reasons such as heat expansions as well as the structure sitting on the ground over time. It is observed that when the tensile or compressive strength is exceeded, as a result of the changes in their behavior, cracks occur due to slippage and pressure in the building elements (Figure 3).

Figure 2. Cracks observed on the wall of the western interior facade of the Saint George Church (left) and a 20 cm fracture occurring in the lower part of the column at the entrance.

It is believed that the physicommechanical damages observed in the carrier system in Saint George Church, as in other historical structures in the city wall in Diyarbakır, are caused by sitting on the ground [15, 21]. It is not difficult to predict that the vegetation in the brick dome of the building will increase over time and cause the collapse of the walls.

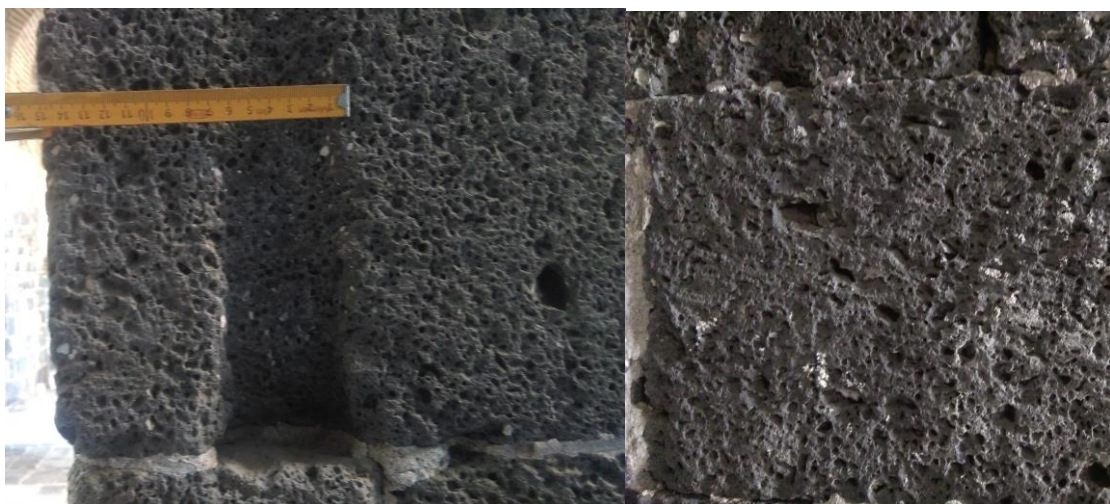
"Honeycomb", which is a type of degradation caused by external atmospheric conditions and erosion, look like honeycombs or sea sponges. This type of change, also called alveolar decay, is a decay frequently observed on the surfaces of church basalt building blocks (Figure 3).

Figure 3. The formation of honeycomb type weathering on the north interior wall of the Saint George Church is seen.

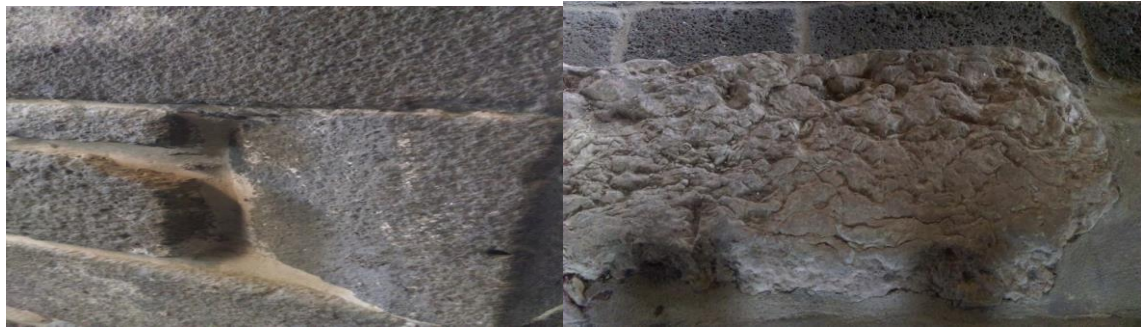
"The repeated abrasion effect of feet" is common in thresholds and it is done by constant human movement on the courtyard floorings (Figure 4). It is manifested by the disappearance of a large part of the original surface of the stone more than 5 cm.

Figure 2. 8 cm abrasion (left) on the wall in the southern interior of Saint George Church (left) and abrasion occurring in the threshold in front of the entrance door

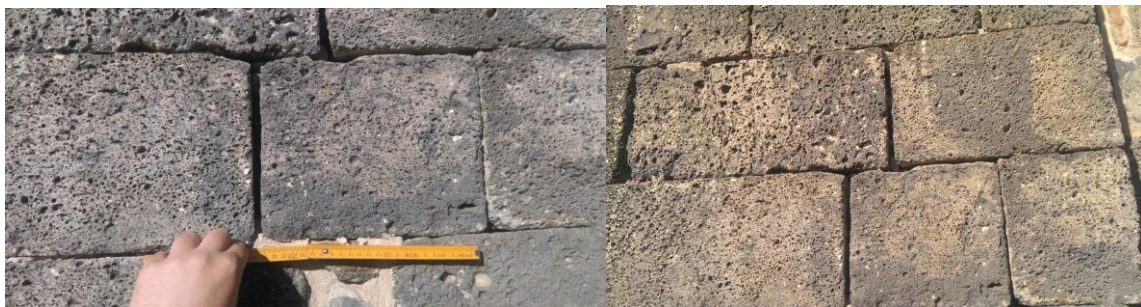
The stones are weakened and dissolved over time due to various reasons, especially as a result of washing. The mortars separated from the stones cause the joints to drain. Gaps of various depths and sizes are formed between the stones. It manifests itself as "joint discharge" in some of the building walls (Figure 5). It is believed that it accelerates other decays as it also causes the floor and ceiling surfaces of the stones to be exposed. Joint discharge is seen more clearly in the buttresses located on the outer facade of the entrance door of the church.

Figure 5. Examples of the type of decomposition related to 10mm joint discharge (left) occurring on the eastern exterior of the church and joint discharge occurring on the south outer facade.

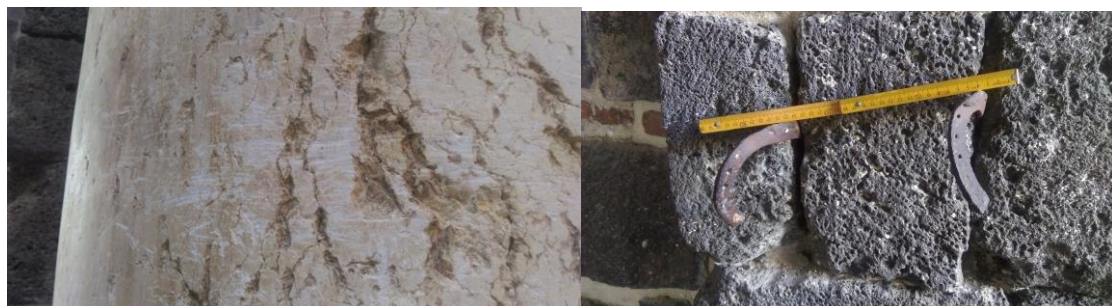
Unfortunately, "Graffiti" observed in almost all historical buildings can be seen in the architectural elements of the Saint George Church. It is a very common visitor behavior that "scratching" the stone surface by drawing it with a pointed object. The Saint George Church was damaged by scratching (Figure 6).

Figure 6. Graffiti was created by visitors by drawing with a pointed object in the limestone columns of the church (left). Metal objects was fixed on basalt wall stones (Right).

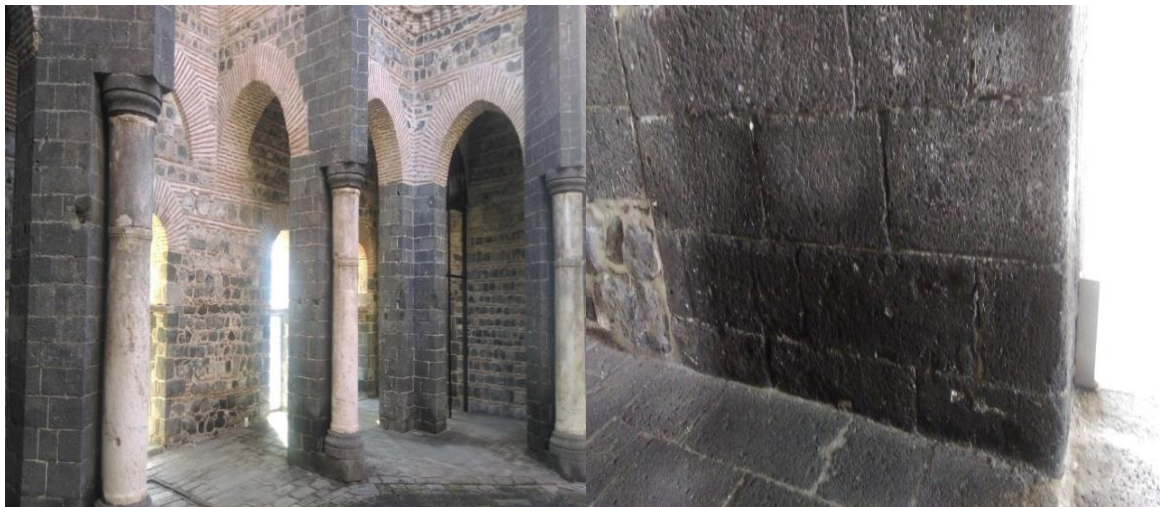
"Surface contamination", defined as the accumulation of foreign matter that does not belong to stone, develops depending on the environmental climate conditions. Especially in the industrial areas, besides the gases released to the atmosphere for various reasons, fuel consumption and exhaust gases that increase due to the long winter season cause intense air pollution and cause pollution on the buildings. Polluted compounds such as gas and particulate nitrogen, sulfur, nitrate (NO_2) in the atmosphere accumulate on the surface over time. This accumulation on the stone surfaces reacts in a humid environment formed by snow and rain and has an acidic effect and accelerates the abrasion by converting calcium carbonate (lime) into gypsum (gypsum), one of the main components of the stone. Such degradation, the main factors of which are the humidity and temperature in the environment, develops as a result of a chemical interaction. This situation is observed both on the outer and inner walls of the Saint George Church (Figure 7).

Figure 7. Black layer formation on the columns of Saint George Church (left) and black layer formation under the western wall of the church can be evidently seen.

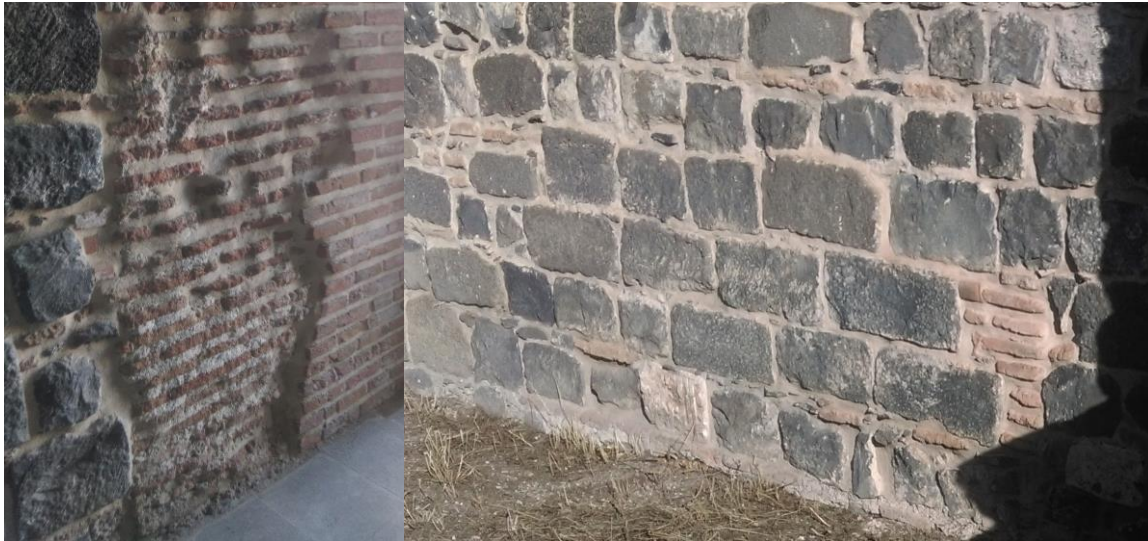
Another type of degradation that is frequently seen in open-air structures is "erosion". It develops with the freeze-thaw cycle for many years and as a result it manifests as loss of material on the stone surface (Figure 8).

Soluble salt crystallization mechanism is frequently seen in building stones. Salts that settle in stone pores with the help of moisture turn into solid-state with the increase of heat and begin to crystallize [9]. In cases where the increased volume of salt particles cannot reach the surface of the stone, it stays in the pores and increases its volume, which causes micro-cracks in the stone. These capillary cracks turn into large cracks with the effect of other factors over time, leading to stone breaks [10]. "Salt accumulation" was found on some walls of the church. Because the basalt building stones has a porous structure, the salts are brought to the surface with water. In the next stage, salt crystals form on the surface during the evaporation of water. Salt crystallization on the stones of the church walls causes damage to the joint fillings (Figure 8). Besides, as the stones at the bottom of the wall absorb water and raise it to the upper sections, molten salts are carried to the upper surface of the wall [11]. With the increasing temperature, the evaporation of water from the rock surface and the formation of hard crusts with the melting salts accumulating on the stone surface [12] are also observed in some walls of the church.

Figure 8. Surface erosion (left) is observed on a brick wall on the western interior of the church and salt accumulations is also observed on the wall of the church south interior facade.

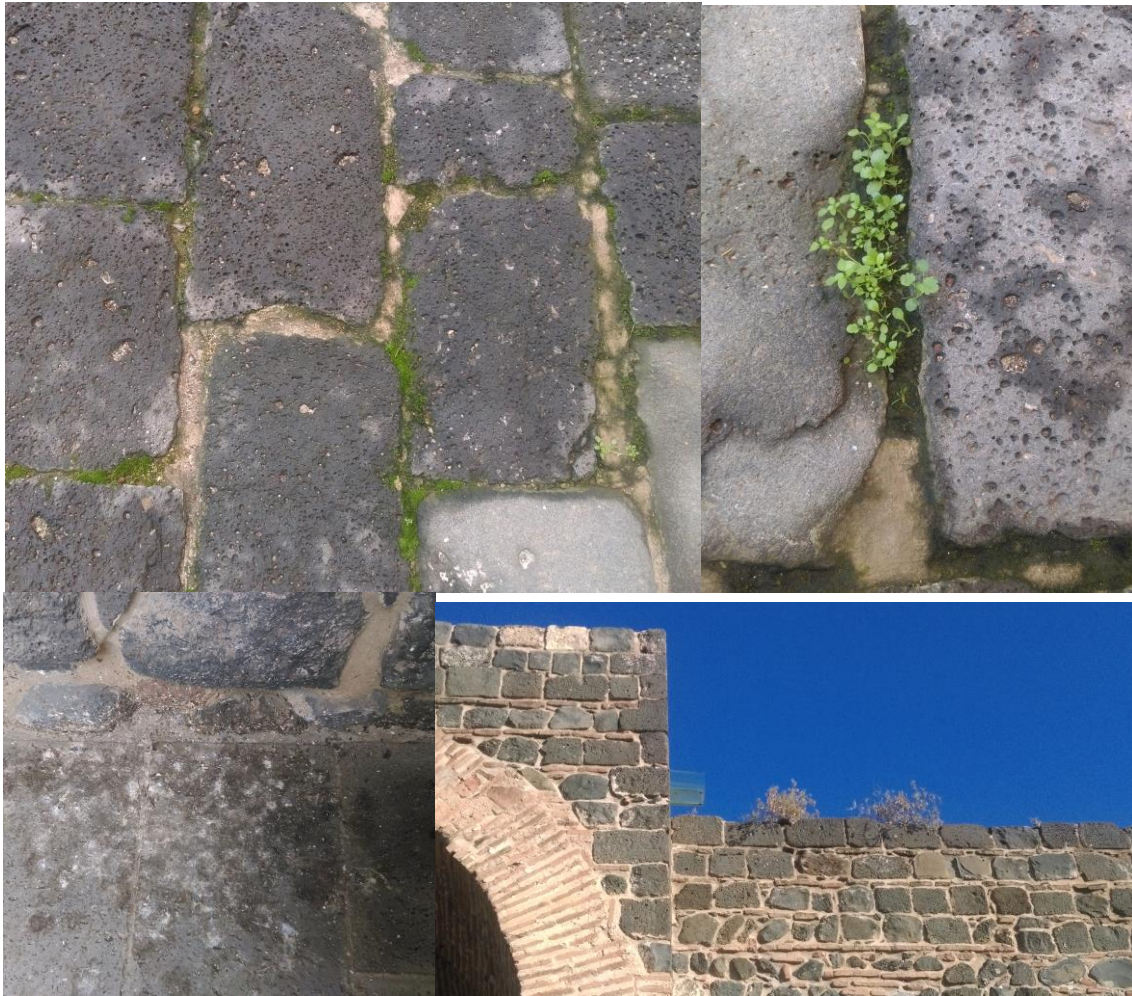
The basalt stones used in Saint George Church have high capillarity due to being porous structure. In this way, the stones remain constantly moist by absorbing the water, which creates an environment suitable for the development of algae between the joints. It is a consequence of the more abrasions of the stones used in the walls of the building close to the ground. This moisture changes the color of the stones since it causes accumulation and contamination on the surface. In addition to the algae formed on the floor stone surface in the courtyard, high plants that developed in the walls of the church and the joint cavities have been observed to affect the stones negatively with the physical pressure they have with their roots and the oxalic acid effect they secrete over time (Figure 9).

In addition to the damage of birds to architectural building stones, the insects create holes in the stones with mechanical effects such as scraping and climbing. They also cause chemical degradation with high levels of organic acids [16, 17, 18, 19]. Also, it is determined that bacteria that hold nitrogen from organic matter and atmosphere also accelerate the degradation by accumulating on the weathered stone surfaces. Due to the accommodation of birds in some parts of the building and especially the substances contained in pigeon droppings, it causes degradation by showing acidic properties. The accumulation of bird droppings observed in different parts of the building may cause material loss and color change over time (Figure 9).

Figure 9. Different types of vegetal colonization are observed on church walls and flooring: Moss development (top-left) between the paving stones on the courtyard floor; herbaceous plants (top-right) formed between the wall joints; herbaceous plant formation on the wall destroyed by algae (bottom-left) occurring in the ground stones in the courtyard of the church.

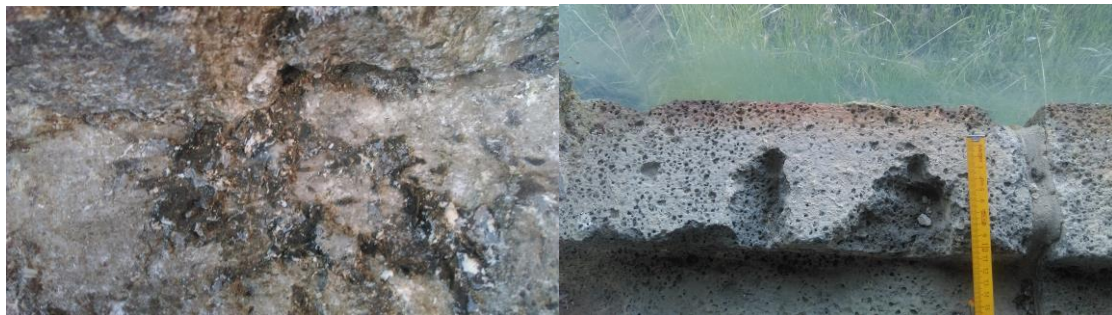
Color change was also observed in some building blocks of Saint George Church (Figure 10). It is known that this color change may develop by decomposition of the minerals contained in the basalt stone as well as due to biological factors [20]. It can be said that the reason for the color change seen in the stones in the church is the iron oxide origin that occurs on the surface as a result of the meeting of the stone minerals with water.

Figure 10. Biodegradation caused by bird droppings on the ground at the south facade of the courtyard of Saint George Church (left). Color change is observed in basalt stones on the church walls (right)
