## **Evaluation of Diyarbakir Armenian Churches in Lower Mesopotamia Region**

### **ABSTRACT**

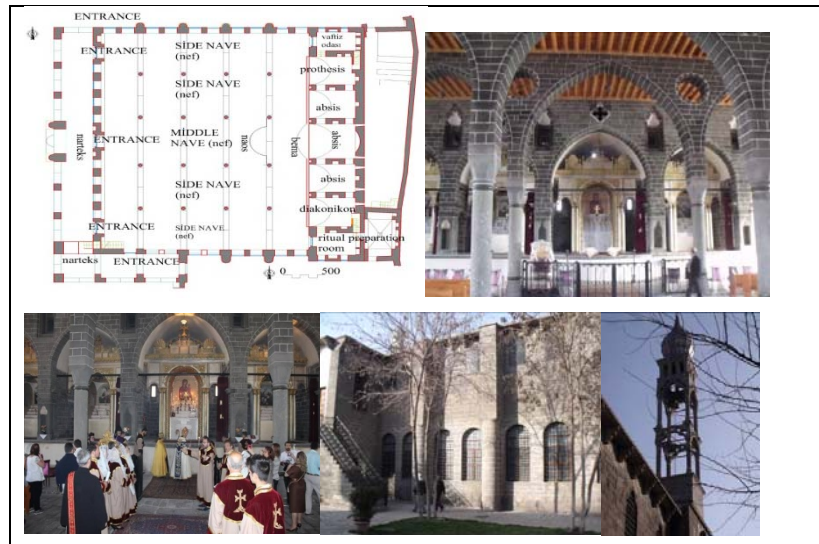
Fig.3. SurpGiragos Church of the year 2014 - Plan and inner appearances

The church has five naves and it is built according to a basilica plan. The gallery can be reached from the south by a staircase. Emphasizing the sacred orientation, the eastern face of the Naos (Shrine) consists of a main abscissa with a circular section behind five arches and two abscissas on both sides of the main abscissa. Therefore, the passage between abscissa is made through the curved arched doors. To the north of the abscissa, there is a prothesis (altar) and a baptistery. The year of 1883 is marked on the baptistery's gate. Upper floor rooms can be accessed from the stairs built in the side apsis wall built beside the main apse (Fig.3).

The southern front, the short section of the L-shaped narthex, consists of the naos wall, the upstairs rooms, and the ritual preparation room, which is located under the upstairs rooms. There are two windows with semi-circular towards the narthex, which is divided by lancet slots, and entrance for women with a depressed arch. The Western front is the front where the passage with seven arches, which are towards the L-shaped narthex, is located. On the narthex, there is a round-shaped balcony with an exterior wall of gallery floor at a higher level of gallery floor above the main entrance pavilion. The large main entrance gate in the middle and the doors on the right and left end grants the entrance to the naos from the western part of the narthex. The bell tower is situated on this front.

On the south front, there are two pillars and on the north front, there are four pillars (supporting walls) in the round and square forms. There are four windows between each pillar, two on top of each other. Between 2009 and 2012, the community and Diyarbakir Municipality repaired the bulb bell tower, which was known but destroyed, was renovated. The restoration of the building was completed in 2014 and the church was opened to worship.

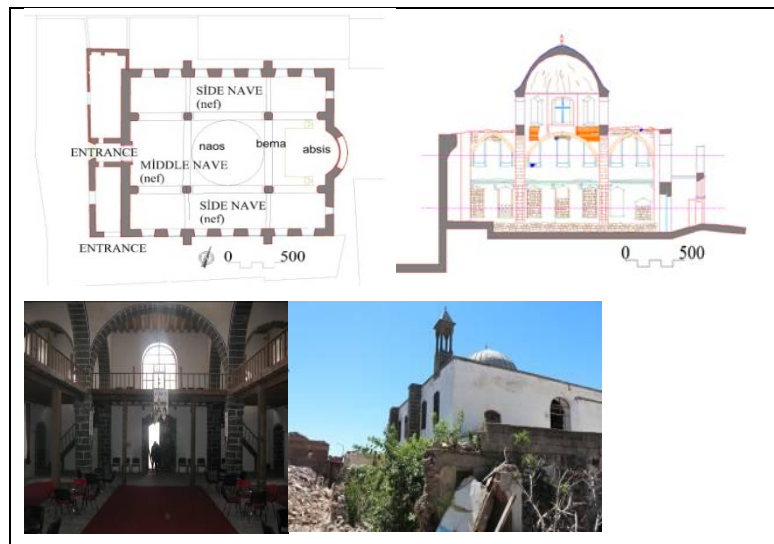
Fig. 4. SurpPirgic Church floor plan, sections (DVBM Archive), view of abscissa from the gallery, south façade

The abscissa of the church is externally emphasized and internally rounded. The bema podium built in front of the abscissa is accessed by a two-stepped staircase. There is a wooden gallery floor rotating the western, northern and southern wings in U shape. The wooden stairs leading to the gallery floor are built in the northwest and southwest of the naos. On the north of the church, there is a lead-covered bell tower (Fig. 4).

Unlike the other Armenian Churches in Diyarbakır, the structure was planned as a closed Greek cross (Fig. 5.). The narthex is located in the north-south direction to the west of the structure. There are three naves in the church, while the center was the timber-framed dome, the sidewalls comprise flat roof on wooden beams. Diyarbakir is the only church, which uses a dome. In addition to the main entrance at the west, the church also has entrances in the north and south directions.

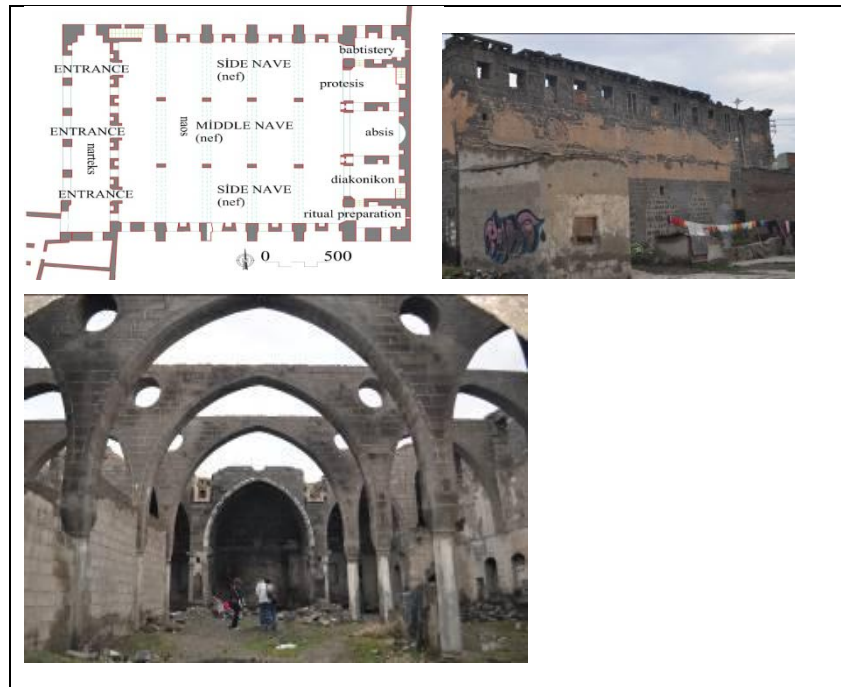
Fig. 6. SurpSarkis Church first floor plan (Tuncer, 2002), west front and view of abscissa from the naos

In addition, the naos is divided into three columns with two columns established on square bases. To the east of the naves lies a semi-circular main and side abscissas. There are stairs to reach the upper floor corner rooms inside the walls of the baptistery and the ritual preparation room on the diaconicon cells in the south and prothesis cells in the north.

The walls of the galleries, separated by arches and with rectangular windows, form the front in the west. The narthex is divided into five units by the arches. In addition, the unit in the middle is symmetrically opposite to the front. Behind the narthex, there is a closed door and windows with rectangular gaps on both sides. The eastern front of the church ends with flat walls with small passage windows. The pilasters in the north and south fronts, which are symmetrically arranged, divide the wall surfaces into vertical pieces; each of these pieces contains a door or a window opening. In addition, the western door used by women is emphasized with profiled door frame while the door dedicated to religious officials to the east of the southern wall is simple. Flat lintels were used in every window. The upper and lower floor windows have the same arrangement and the two sides of the fronts are kept small due to the use of doors.

Diyarbakır Armenian Surp (also known as Small Church, Hıdırİlyas Church) belongs to the SurpGregos Churches Foundation and it is in ruins and vacant. In the repair inscription, the construction date is written as 1840 AD. Berchem and Stryzowski admit that the church dates to the 16th century (Korkmaz, 2006). The church has three naves and it is built according to a basilica plan. In the west, there is a narthex, which is partially collapsed, consisting of five pieces. The entrance to the church is granted by the main door in the middle of the narthex and doors at the both sides of the church (Fig.6). The church resembles the Armenian Catholic Church in terms of its plan layout and front features.
